Compilation of Opacity Monitor Performance Audit Results

1. REPORT NO. EPA-340/1-83/011	2.	3. RECIPIENT'S ACCESSION NO. PB84 128321
4. TITLE AND SUBTITLE A Compilation of Opacity Monitor Performance Audit Results		5. REPORT DATE January 1983 6. PERFORMING ORGANIZATION CODE
7. AUTHOR(S) Steve Plaisance		8. PERFORMING ORGANIZATION REPORT NO.
9. PERFORMING ORGANIZATION NAME AND ADDRESS Entropy Environmentalists, Inc. P.O. Box 12291 Research Triangle Park, NC 27709		10. PROGRAM ELEMENT NO. 11. CONTRACT/GRANT NO. 68-01-6317
12. SPONSORING AGENCY NAME AND ADDRESS OAQPS Stationary Source Compliance Division Waterside Mall, 401 M Street, SW Washington, DC 20460		13. TYPE OF REPORT AND PERIOD COVERED FINAL - IN-HOUSE 14. SPONSORING AGENCY CODE EPA/200/04

A Compilation of Opacity Monitor Performance Audit Results

Steve Plaisance
Entropy Environmentalists, Inc.
Research Triangle Park, North Carolina

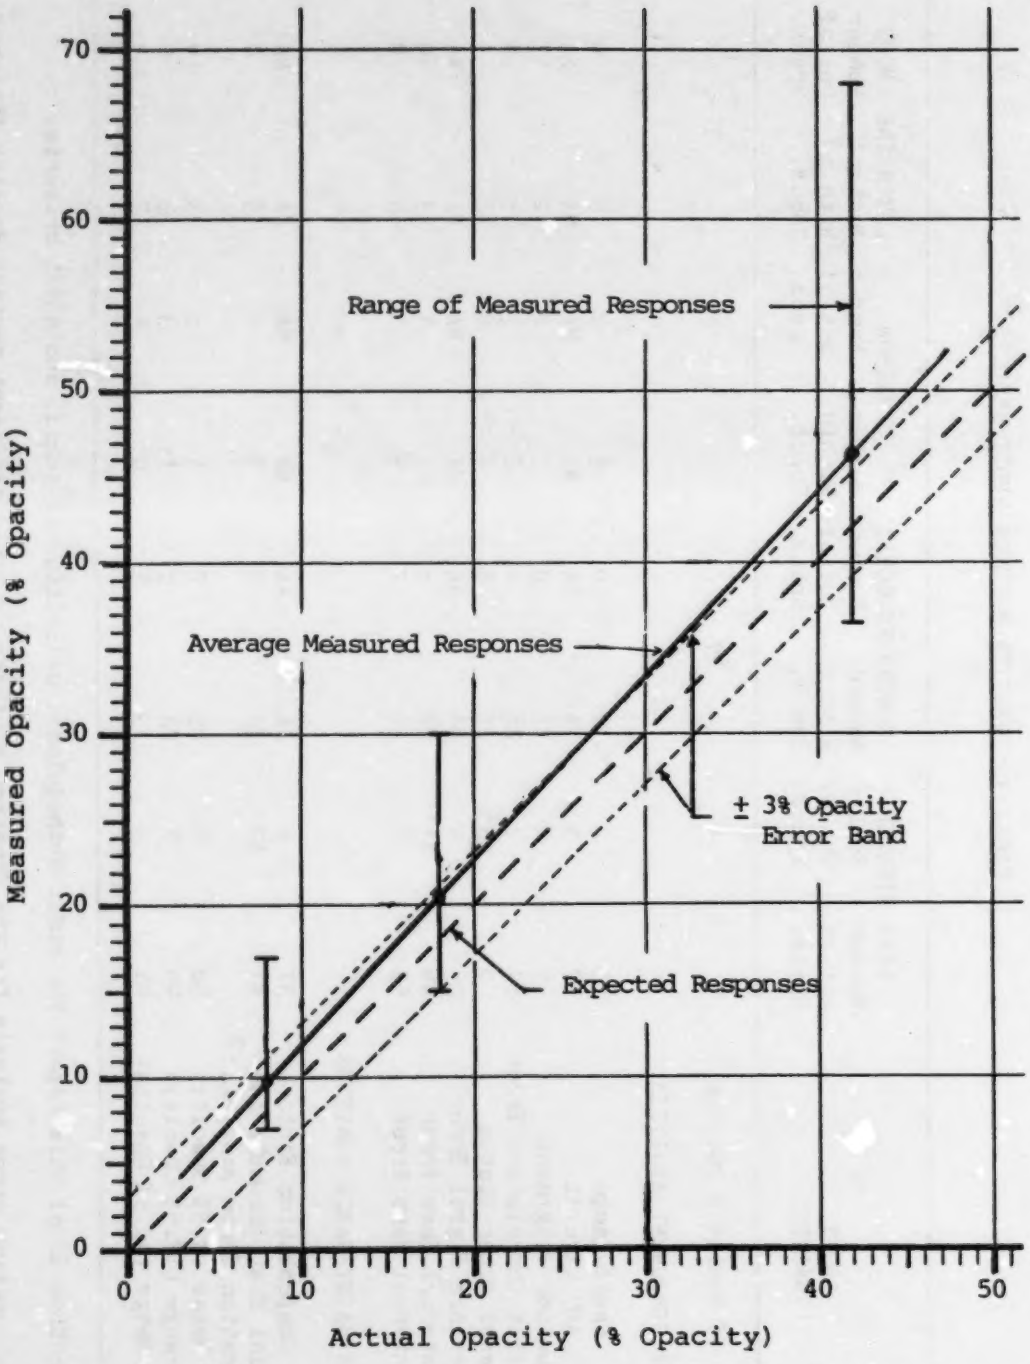
Opacity monitor audit results are summarized and discussed in this section for the four representative types of monitors evaluated. Table 1 summarizes results of the audit analyses of the four monitors. Figure 1 illustrates the relationship between actual and measured opacity for all monitor types, and Figures 2 through 5 illustrate the same relationship for each type of monitor tested.

Figure 1. Observed Opacity Responses for All Audited Monitors: 89 Monitors

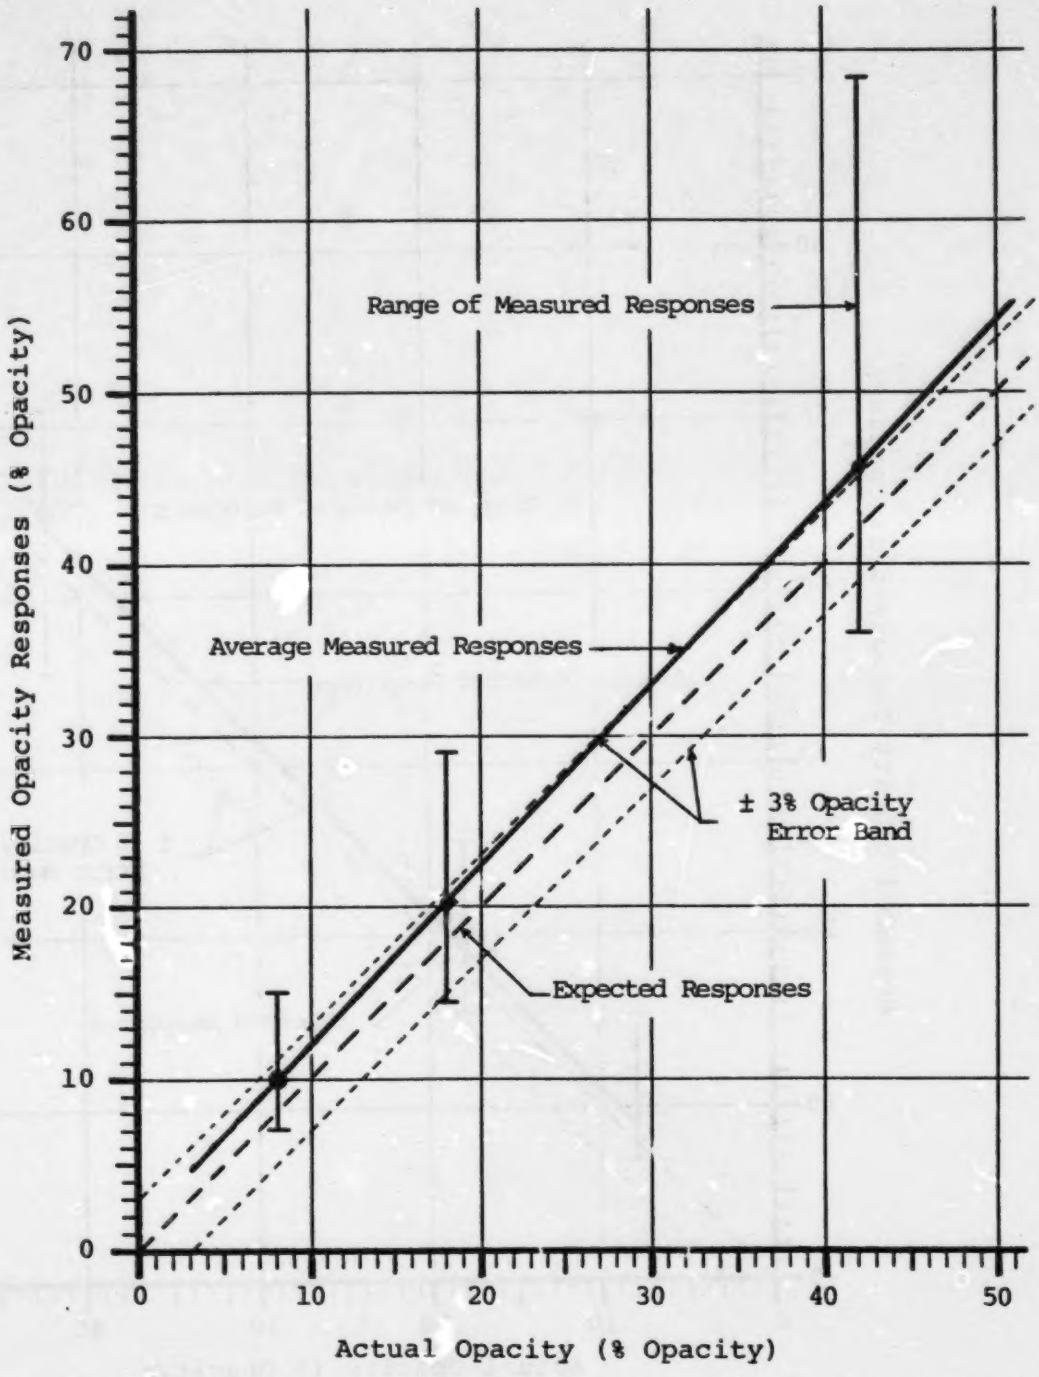
Figure 2. Observed Opacity Responses for 58 Lear Siegler Monitors

Monitor calibration was found to be generally accurate and linear, with the greatest number of "out of specification" monitors resulting from the high range calibration error analysis (9 monitors, or 16 percent of the total). As Figure 2 illustrates, the Lear Siegler monitors tended to give elevated opacity measurements, but typically not in excess of the 3 percent

opacity error band based on average measured responses. However, the range of measured opacities increased disproportionately with increases in the actual opacity, thereby indicating that monitor accuracy deteriorated with higher actual opacity.

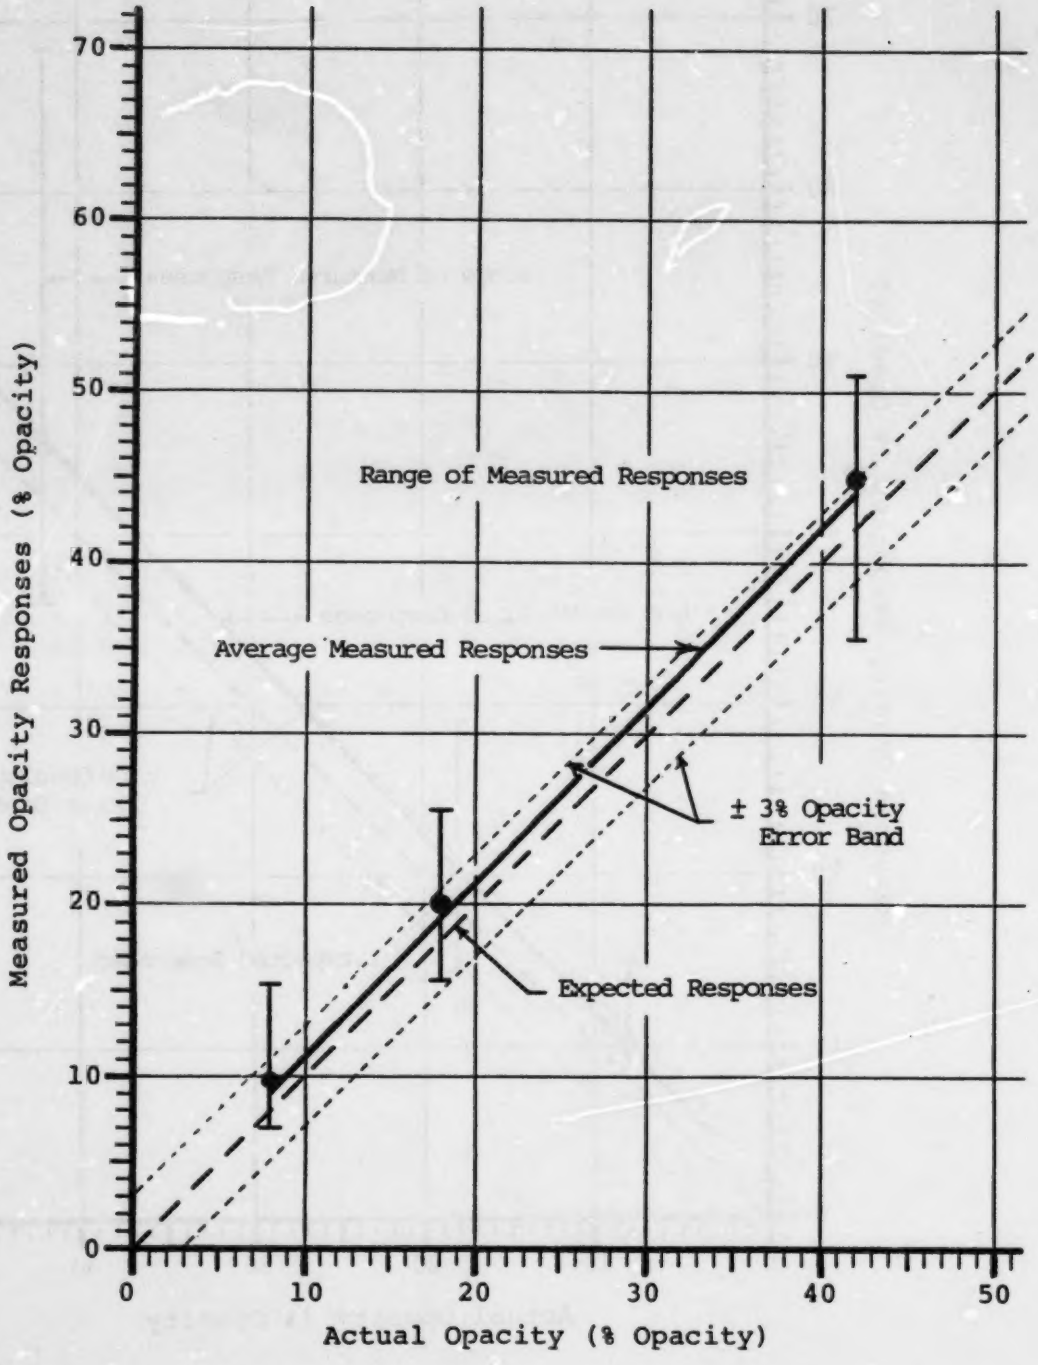
Figure 3. Observed Opacity Responses for 27 Contraves Goerz Monitors

Contraves Goerz. An analysis of the performance of 27 Contraves Goerz monitors indicated that panel meter and internal span errors occurred in about 20 percent of the monitors audited. Monitor maintenance, as indicated by the optical dust accumulation, was generally satisfactory, with only 3 units (about 12 percent of the total) having excessive dust accumulations. Monitor calibration, as illustrated in Figure 3, was adequate, with average low, medium, and high opacity values falling within the ±3 percent opacity error band. Contraves Goerz monitor opacity measurements were typically higher than actual opacity values, and this bias increased with higher actual opacity values.

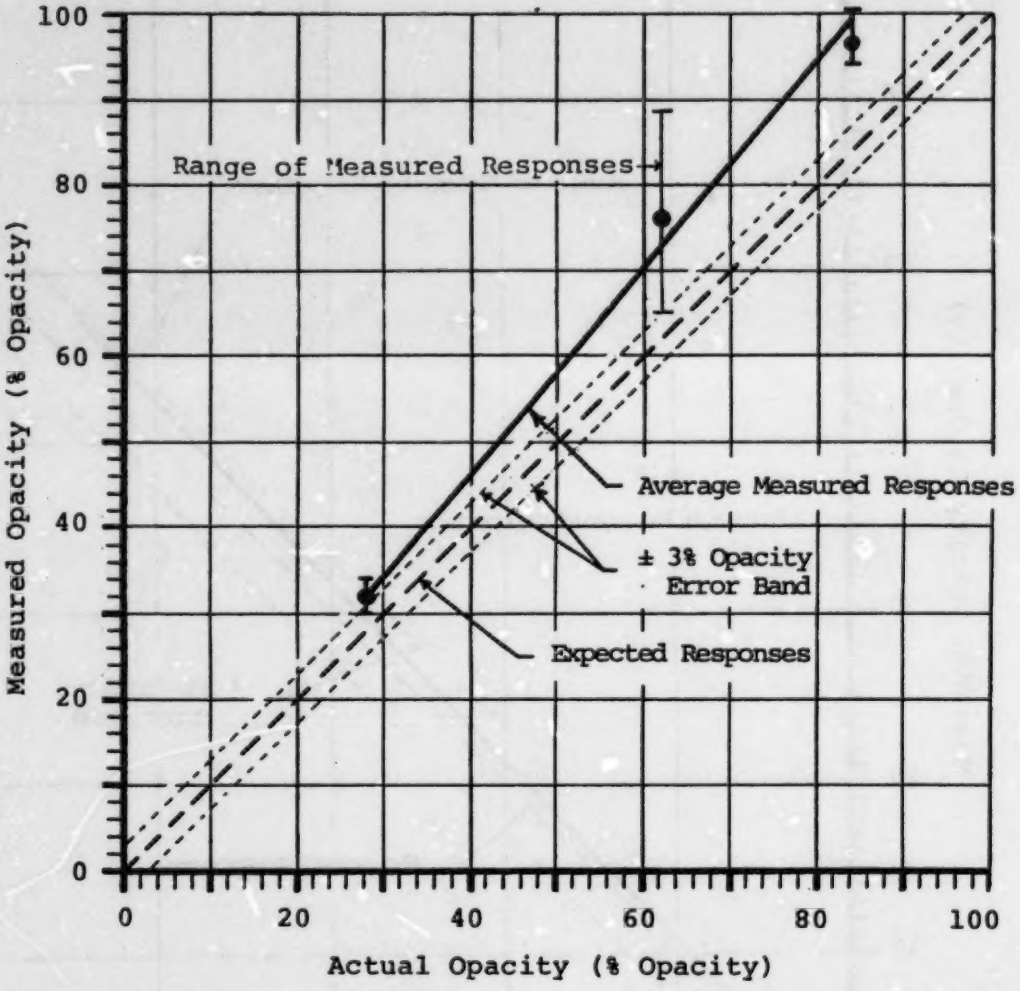
Figure 4. Observed Opacity Responses for 5 Dynatron Monitors

Maintenance of Dynatron monitors, as indicated by dust accumulation on monitor optics, was satisfactory, with only one monitor having excessive dust on system optics. Figure 4 illustrates the very high bias found in the calibration analysis, indicating severe inaccuracies in measured opacity, particularly in the higher range of actual opacity values. In fact, only 25 percent of the Dynatron units were found to be within the acceptable range of accuracy for low and mid-range opacity values. Moreover, monitor linearity was found to be deficient, with average mid-range opacity values having less accuracy than either low or high range opacity values.

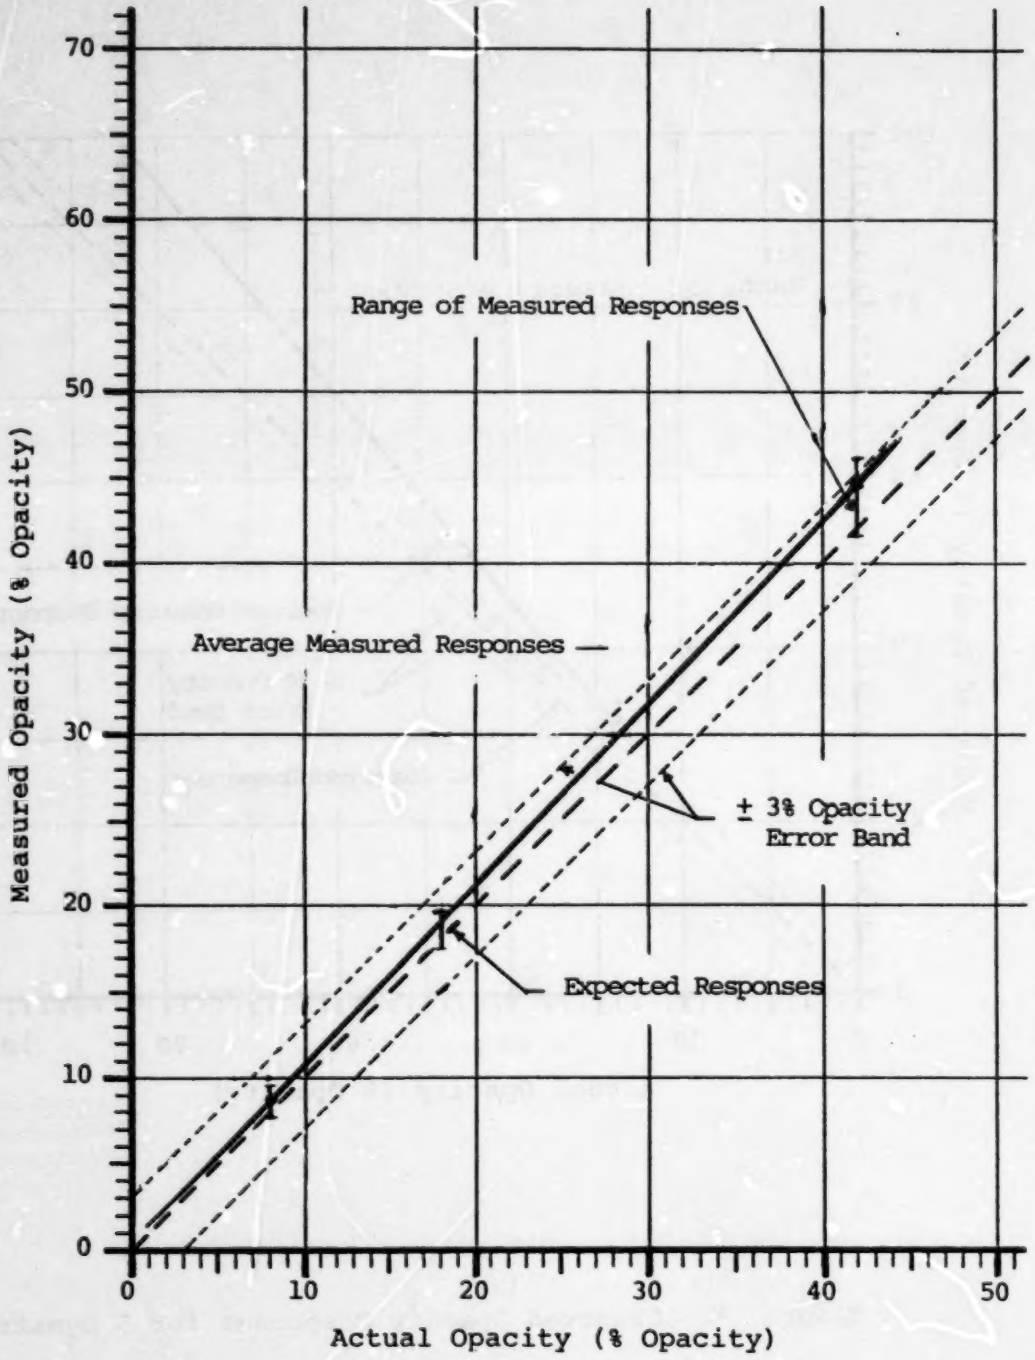
Figure 5. Observed Opacity Responses for 3 Esterline Angus Monitors

Esterline Angus. Of 3 Esterline Angus monitors audited, one unit had problems with monitor alignment and panel meter errors. Optical dust accumulations were found to be minimal, thereby indicating adequate monitor maintenance. Furthermore, only one unit was found to have excessive calibration error (high range). Monitor accuracy and linearity, as illustrated in Figure 5, were satisfactory, with both low and mid-range calibration errors falling well within the ±3 percent error band.
